3.0 LAND USE / SOCIO-ECONOMIC ENVIRONMENT

5.0 SUMMARY OF INPUT RECEIVED ON ENVIRONMENTAL CONDITIONS AND MTO RESPONSES AND CHANGES

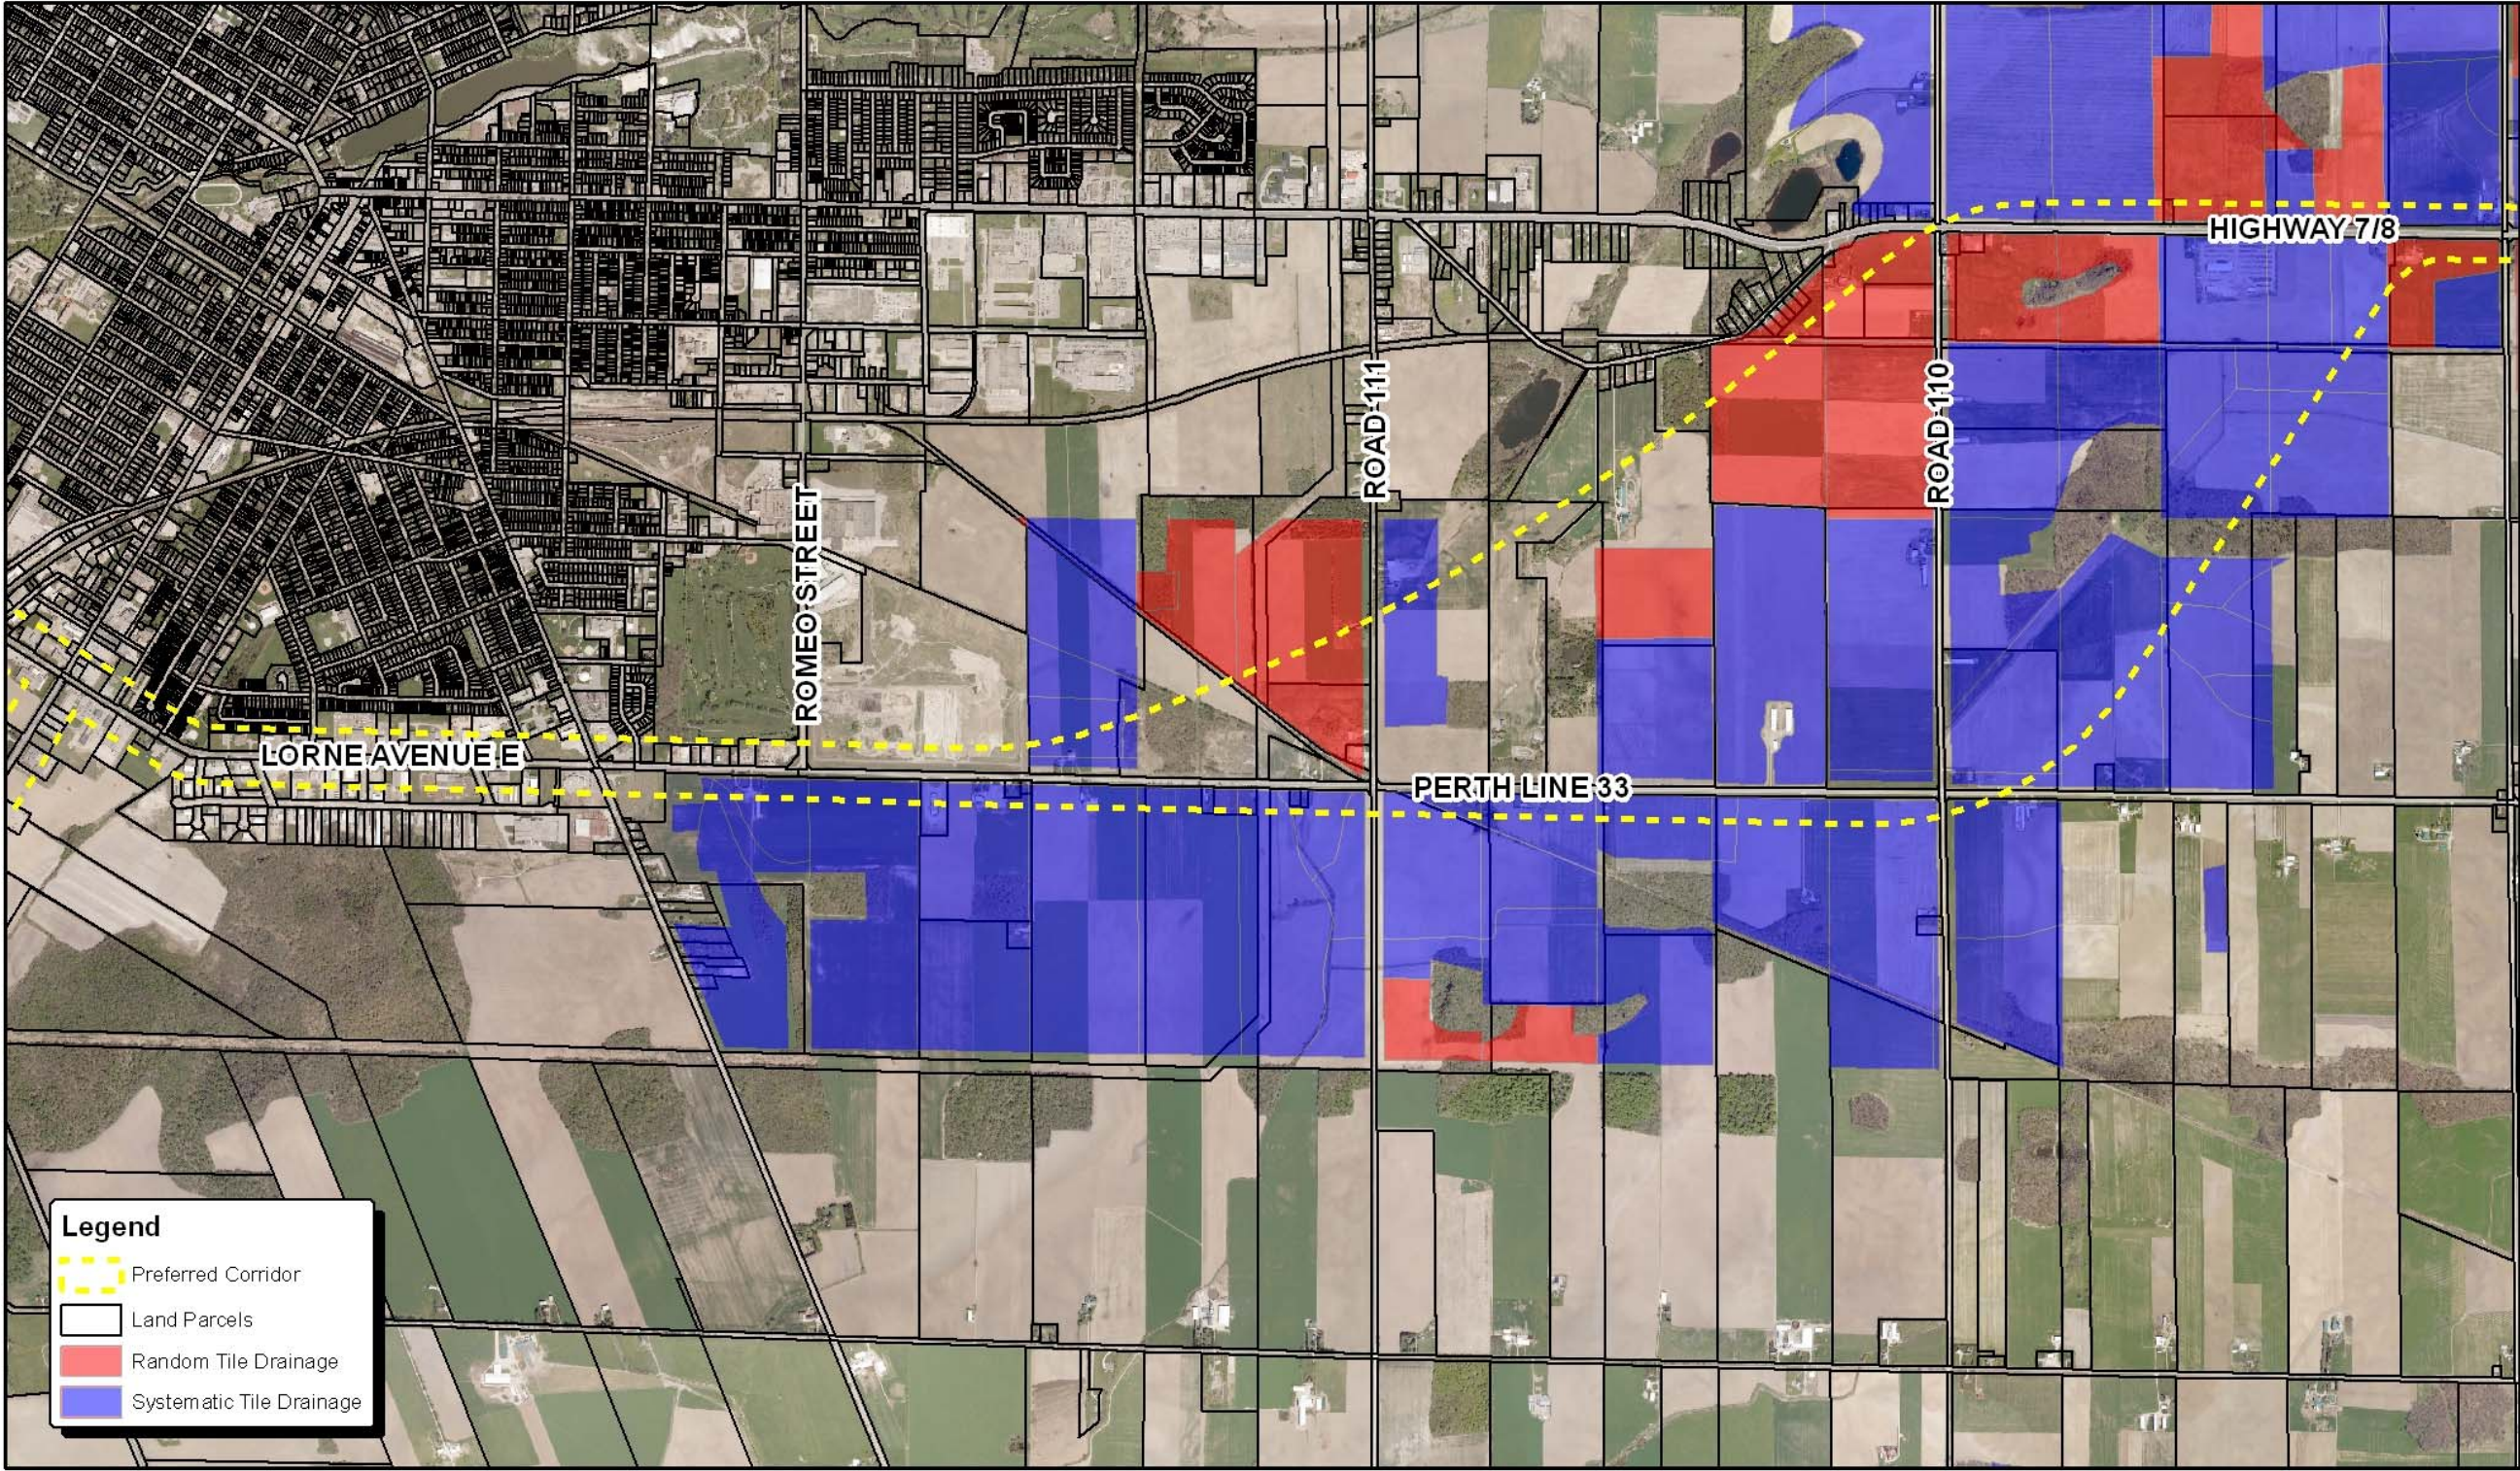
EXHIBIT 3-9(b)
Agriculture - Map of Field Tile Drainage Systems within
the Preferred Corridor

- Preferred Corridor
- Land Parcels
- Random Tile Drainage
- Systematic Tile Drainage

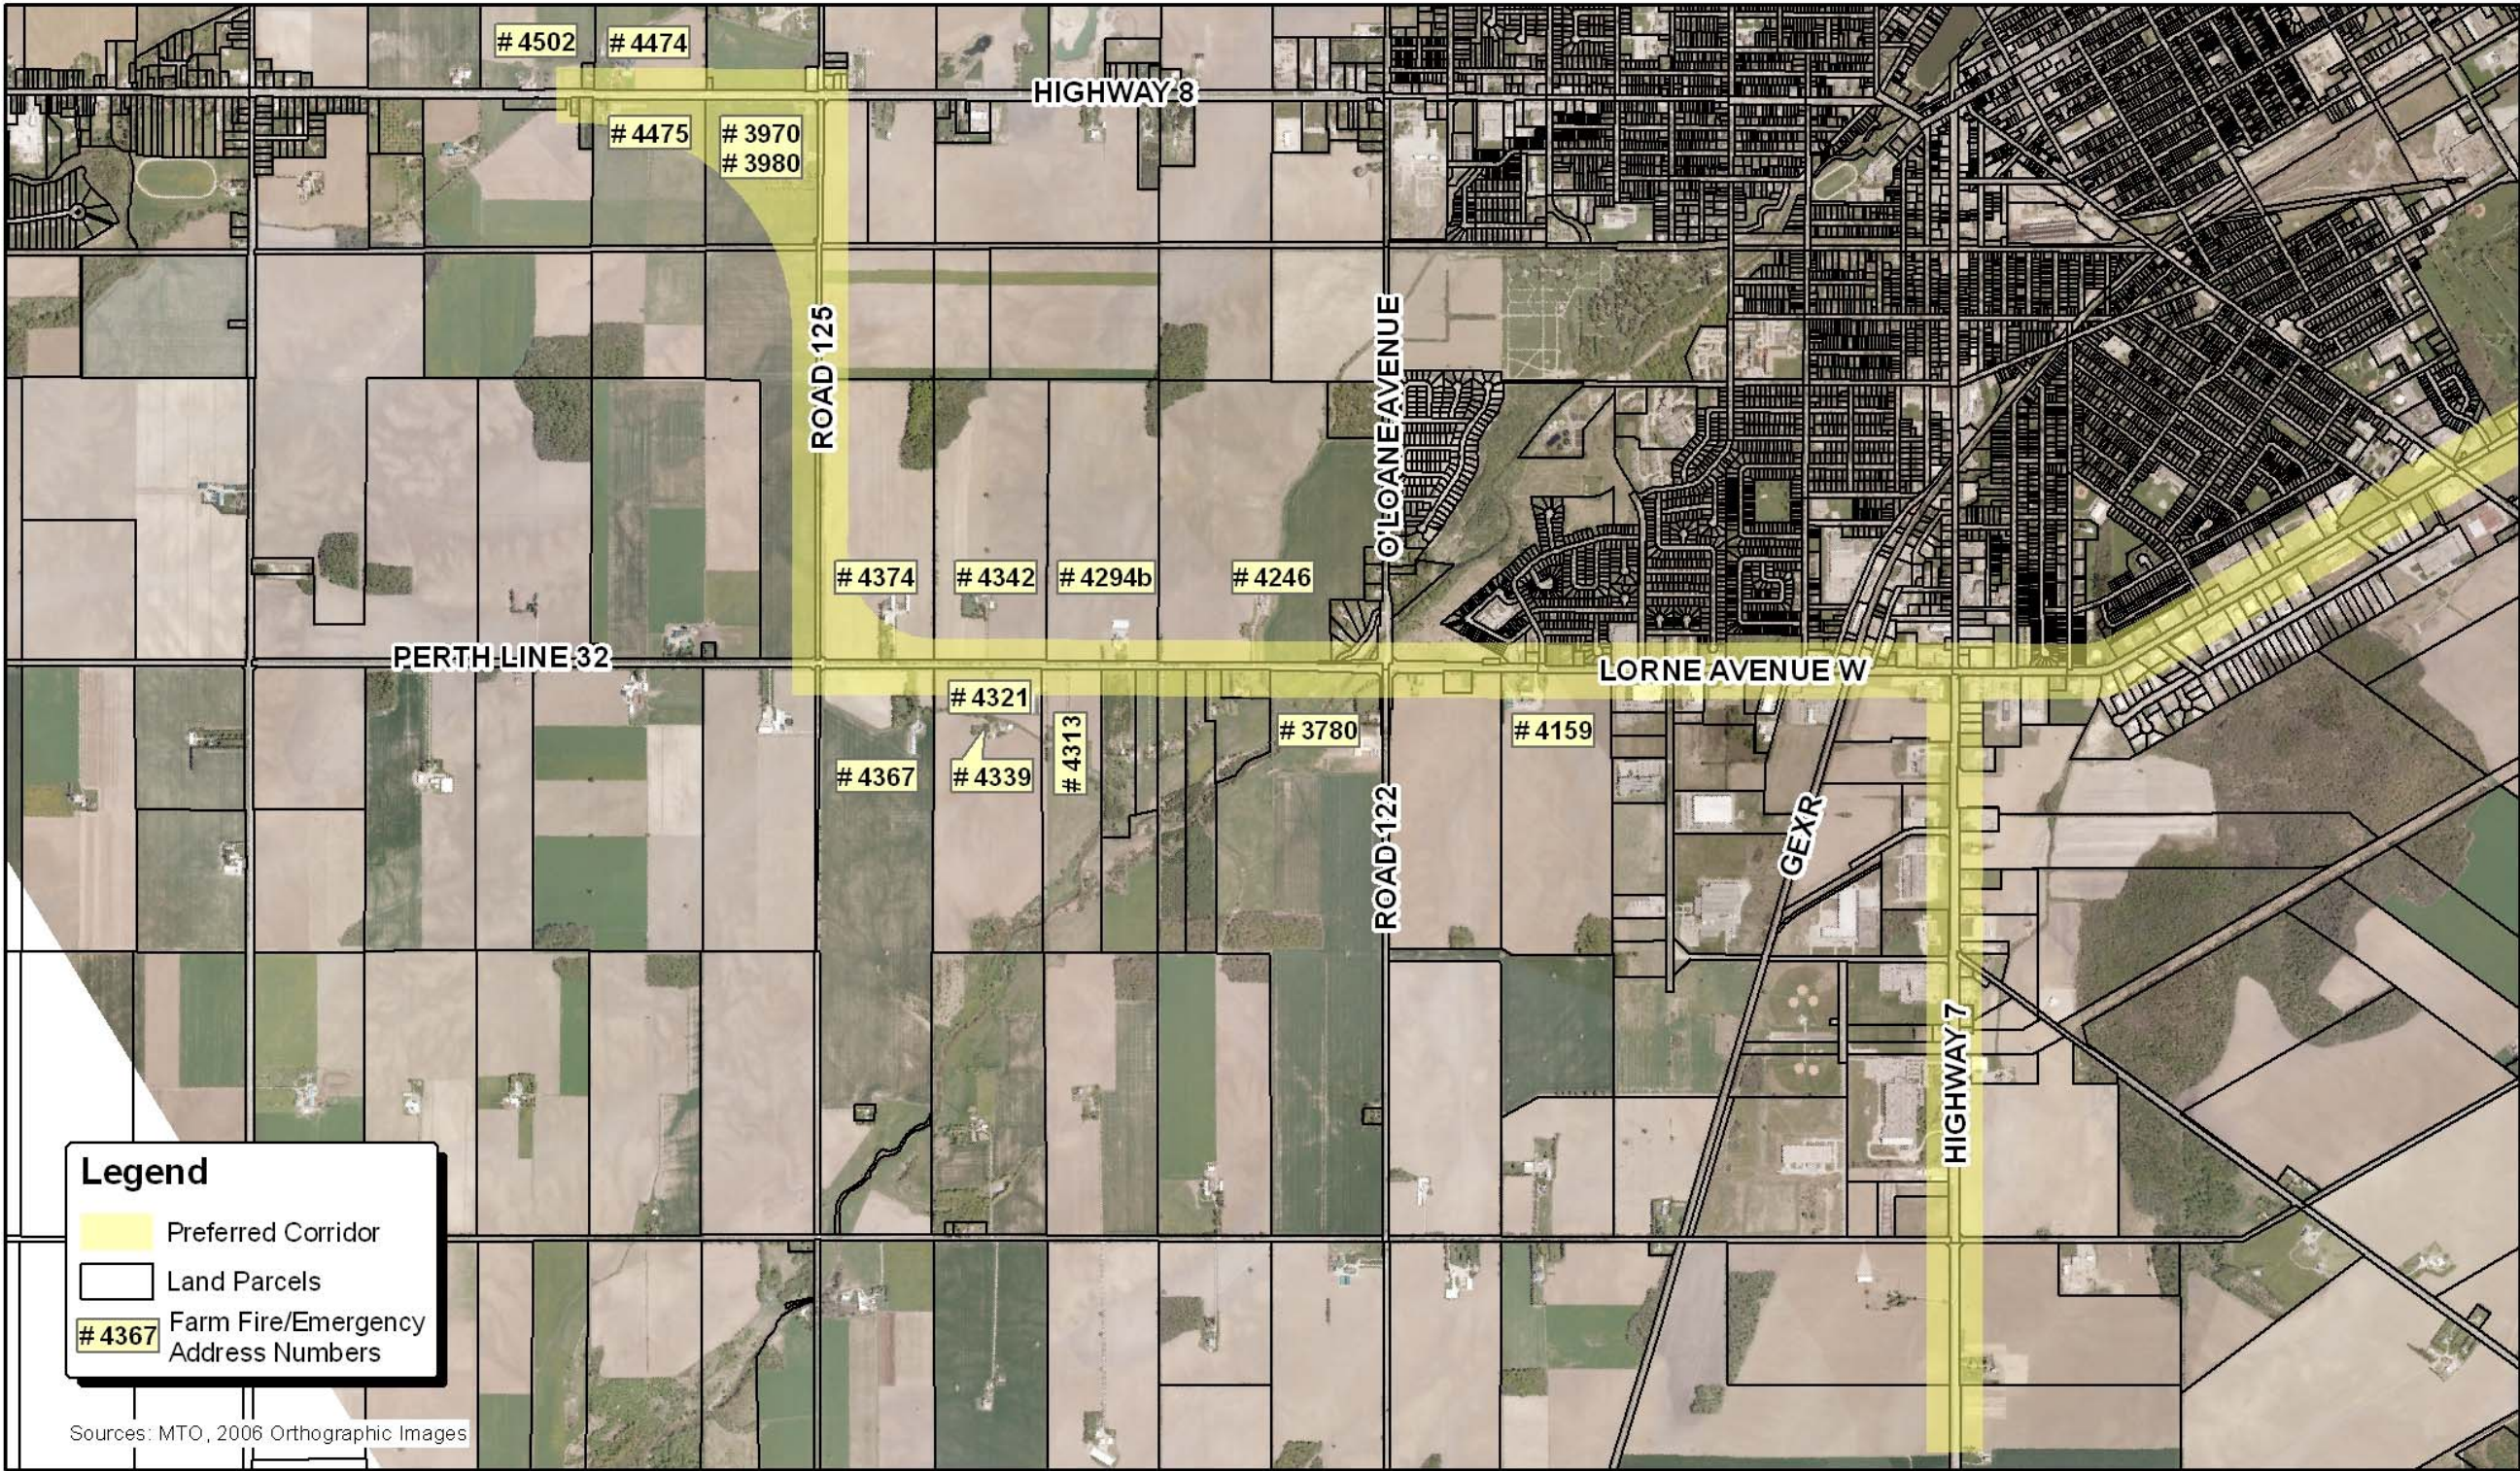
EXHIBIT 3-11(a)
Agriculture - Map of Selected Farm Locations

Note: Purpose of Map is to Show
Locations of Farms Identified in
EXHIBIT 3-10

In June of 2009, members of the project team undertook an inventory of farm buildings within the preferred corridor using aerial photos supplemented by field observations. **Exhibit 3-10** provides the details of this inventory, and **Exhibit 3-11** provides a map that identifies the locations of the farms by fire/emergency address number.
